Kiely Arborist Services LLC

May 11, 2018

Site: Empty lot on Olympian Way, Pacifica, CA

As requested on Wednesday, May 2, 2018, I visited the above site for the purpose of inspecting and commenting on a large Monterey pine tree. A new home is in the process of being designed for this site and your concern as to the future health and safety of the trees has prompted this visit.

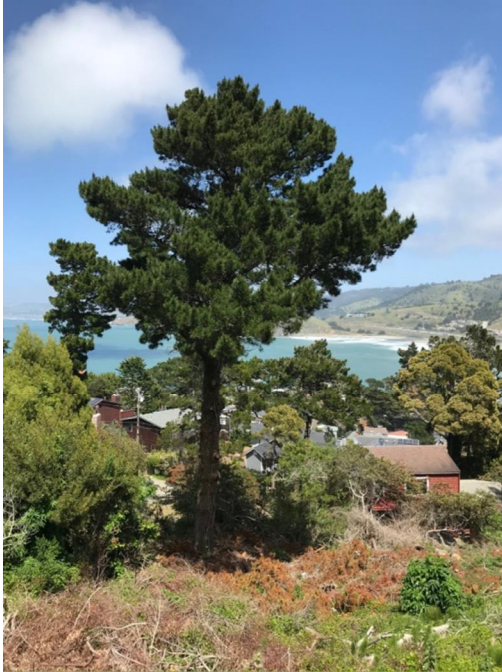
Tree#	Species	DBH	CON	HT/SP	Comments
1	Monterey pine (<i>Pinus radiata</i>)	36.2	65	55/35	Good vigor, fair form, crown raised in past, top heavy, site is heavily slopped, neighboring pine trees infected with pine pitch canker.

Showing Monterey pine tree in question

The Monterey pine tree in question is in fair condition. This tree showed no signs of pine pitch canker disease, but all of the Monterey pine trees on the neighboring properties are showing symptoms of die back related to the fungal disease, indicating the fungal pathogen is in the area. This tree is recommended to be removed for a variety of reasons

- The trees crown has been raised up to 25 feet in the past. Because the tree's crown has been raised, the tree is now top heavy. This make for an elevated risk of limb/top failure as the tree is now subjected to wind throw because the load is not evenly distributed throughout the tree.

- It is necessary to remove this tree in order to let the property owner build a new home on his lot without the threat of a limb failure in close proximity to the proposed structure. Any excavation or grading within 30 feet of the tree would have an impact on the trees health. When this species starts to decline it usually is quickly infected with pine pitch canker and bark beetles.
